**ENVIRONMENTAL FOUNDATION
(GUARANTEE) LIMITED**

ANDA DOLA MINI HYDRO POWER PROJECT

SITE VISIT

05 FEBRUARY 2016

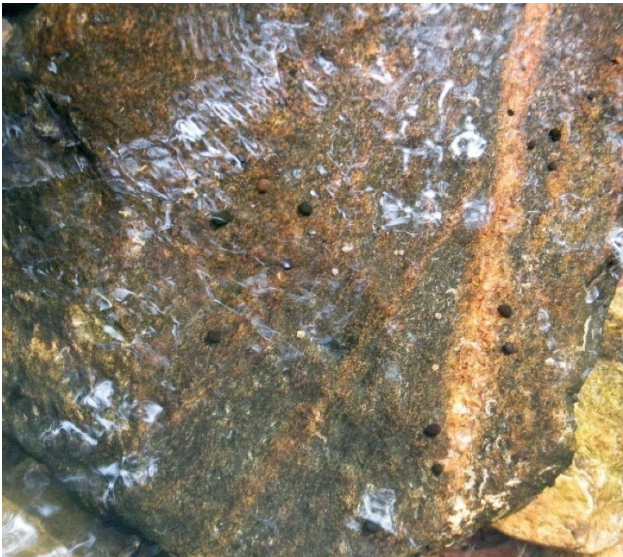
The careless disposal of cement near the river bank has caused an increase in the water snail population in the Anda Dola. The calcium phosphate found in cement stimulates water snails to reproduce more often, resulting in an ecological imbalance as,

A large number of water snails were observed at the weir location

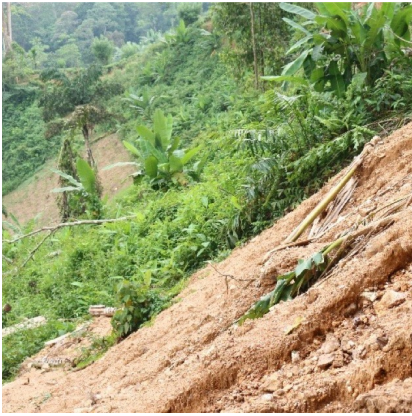
The hilly terrain of the region makes it susceptible to soil erosion

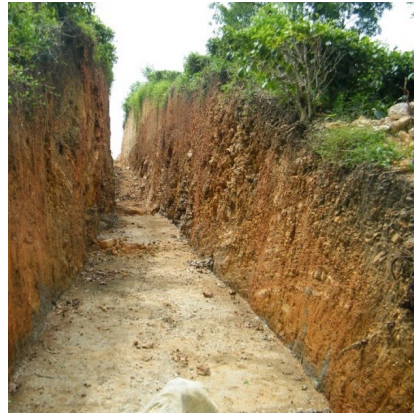
Tea lands on higher elevation have been cut through to construct the penstock

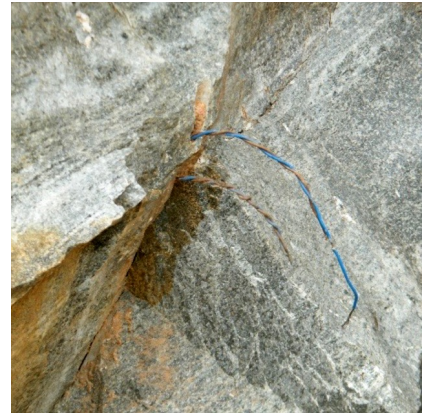
The rock blasting taking place is a threat to soil stability and a disturbance to the fauna

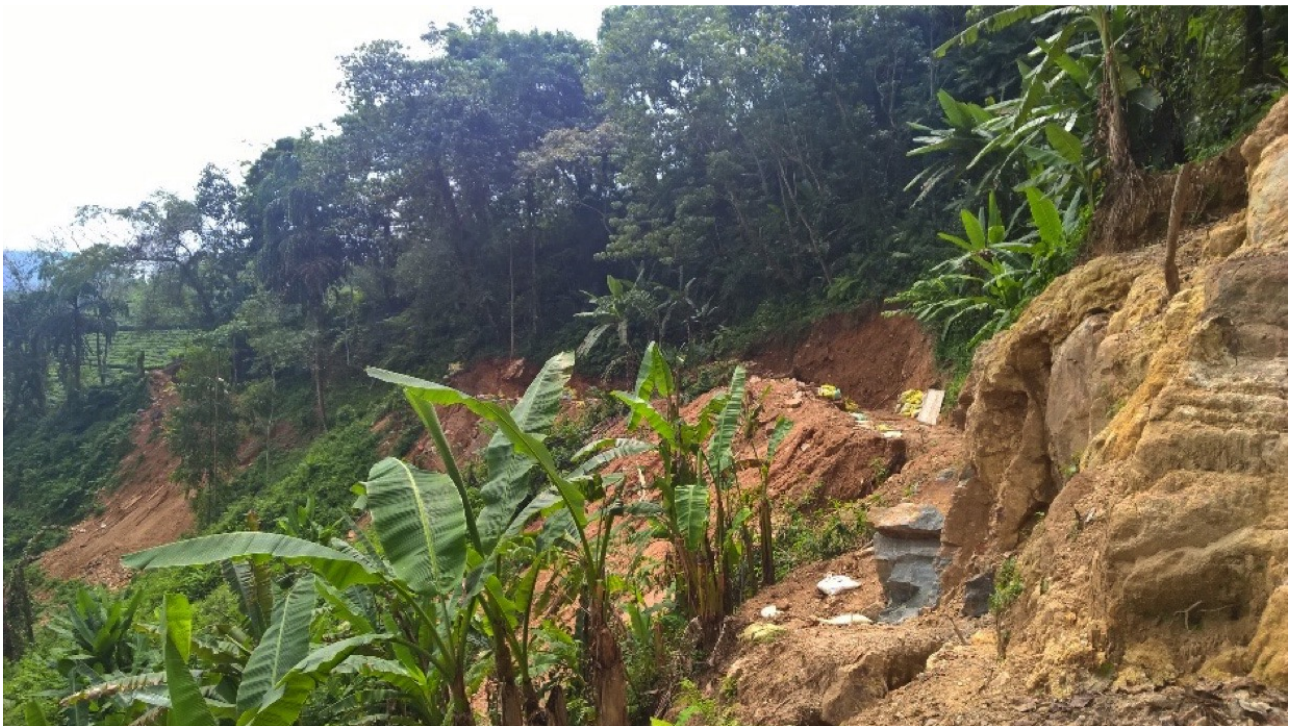
Organization (NBRO) for the district of Galle show that the head-race channel and penstock line come under the “modest level of landslide hazard”. However, the deforestation taking place in the region may increase the risk of landslides and soil erosion.

Part of the penstock has been cut along a slope, increasing risk of earth slips

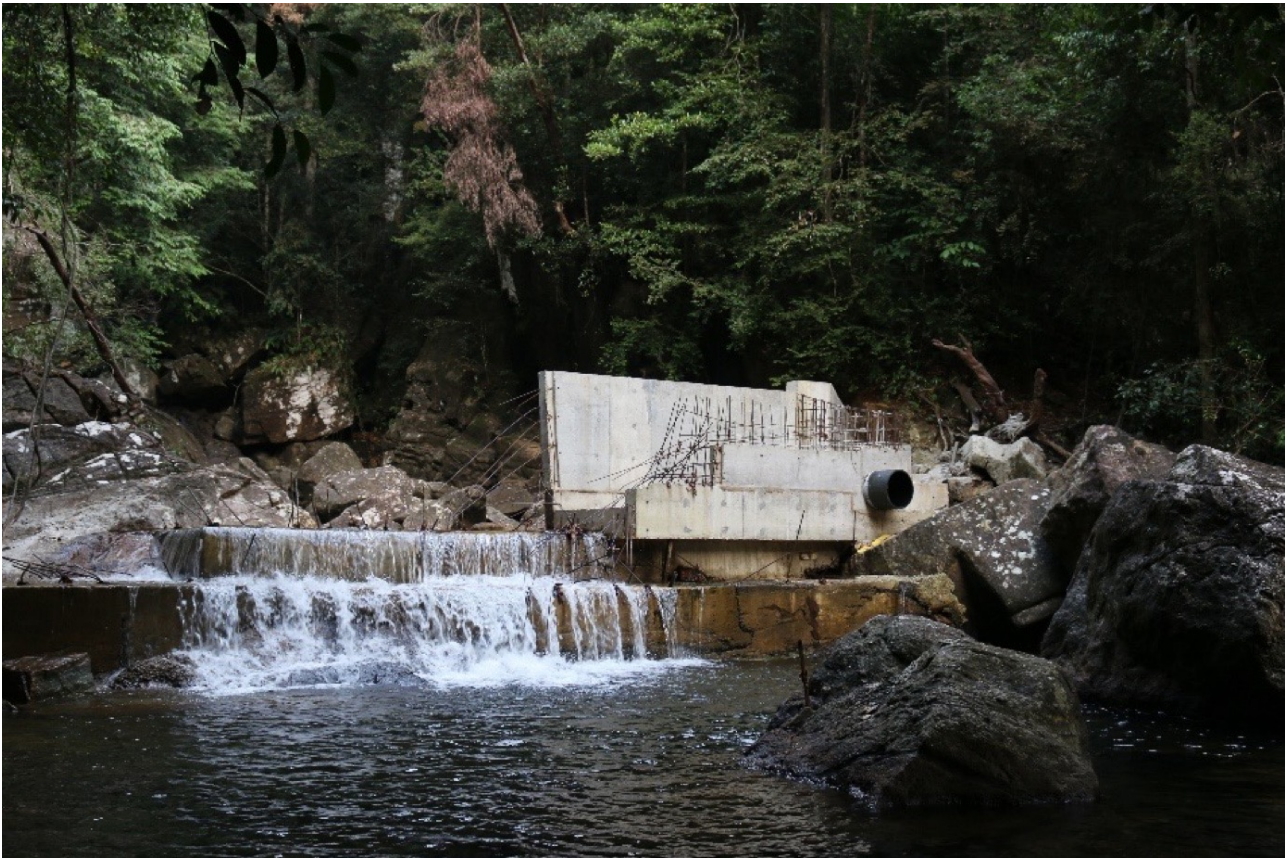
1. The IEE states that the weir will be located 2.2Km away from the confluence point of the Anda Dola and Tumbaperiya Dola but it was found that the weir is 2.8Km away from the point of confluence
2. The weir length stated in the IEE is 12m however the actual length of the weir across the stream is 16.04 m
3. The site visit report clearly states that the weir location is within the Dellawa Forest, yet it has failed to recognize the ecological value of the forest which is a part of the Sinharaja Forest network

The incomplete weir

1. Having visited and analysed the adverse impacts that the project poses at its current construction phase and the anticipated effects of the operational phase, we strongly believe that the project concerned should be stopped. Any damage or disruption to the ecosystem caused by the construction of the project should be identified and restored to its natural state, ensuring that further destruction does not take place.
