ENVIRONMENTAL
FOUNDATION
(GUARANTEE) LIMITED

Report on the visit to the garbage dump at Kotikawatta

20TH APRIL 2017

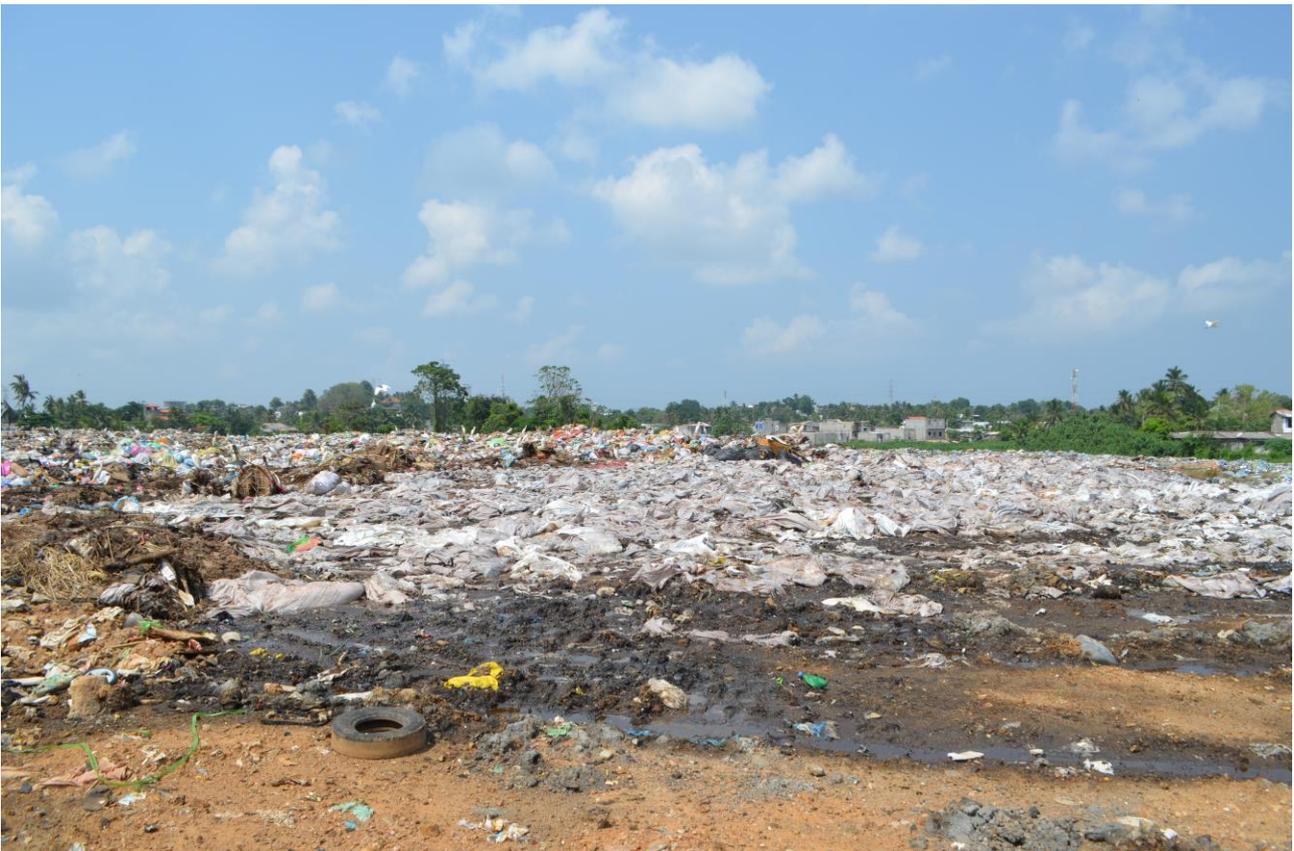
1. The garbage dump spans over an area of more than 10 acres bordering the general cemetery of Kotikawatte – Mulleriyawa, a school (Somadevi Balika, Vidyalaya, Kotikawatte), compounds of houses, and a wetland area of the breadth ranging from 5m – 30m. It was mentioned that about 850 students in the age group of 6-16 study in the school and it has classes from grade 1-11.

Figure 1 The Garbage dump with houses at a distance

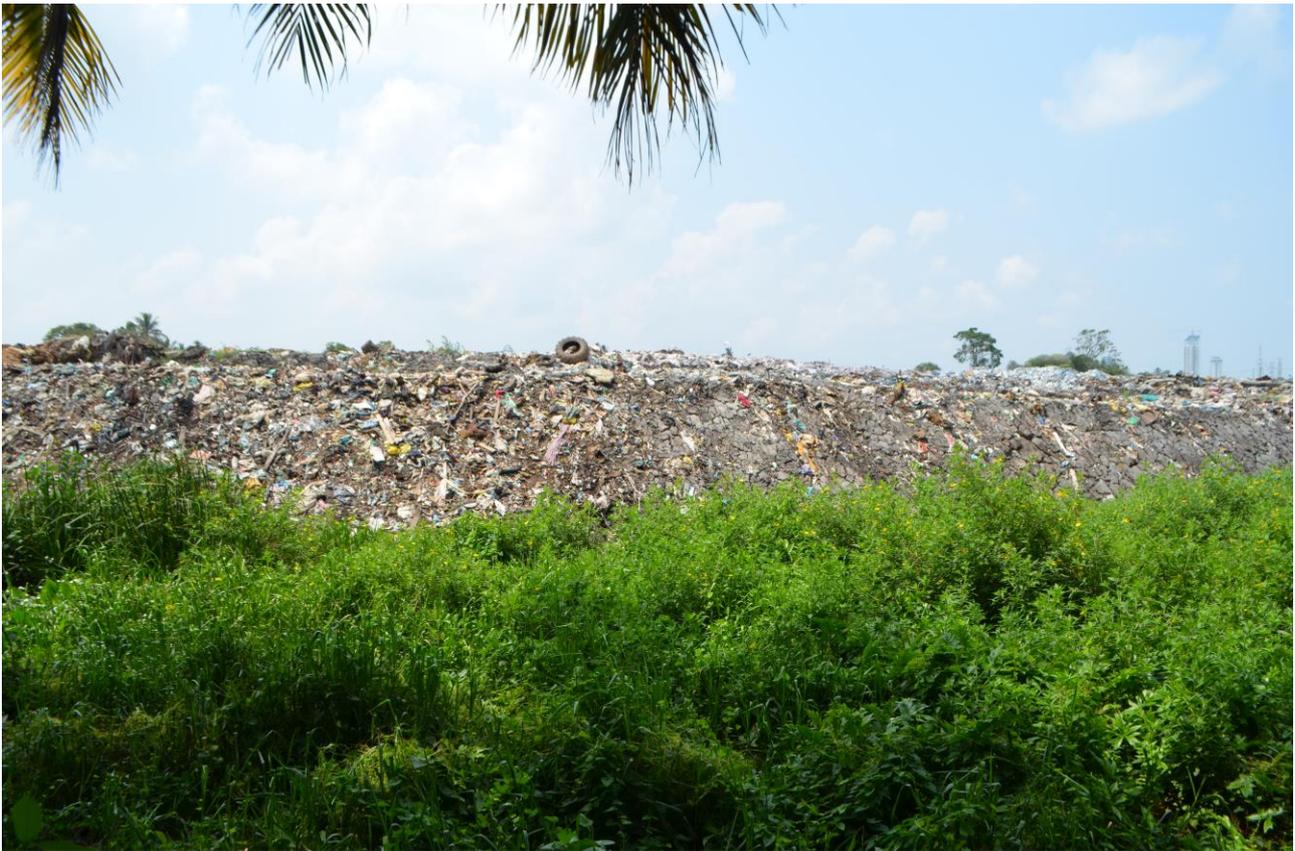
Figure 2 The dump as seen from a kitchen of a neighbouring house

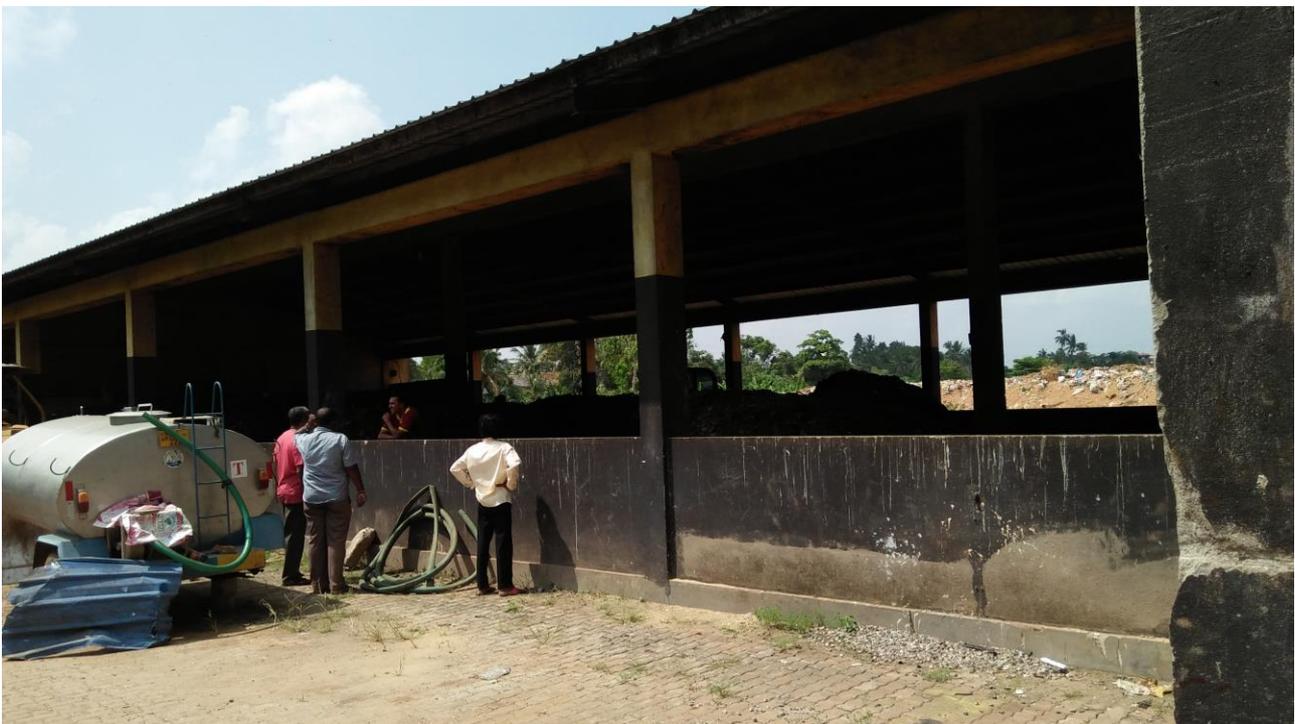
2. Down the cemetery, a small composting facility was observed. As per observations, its capacity seemed very limited, obviously not catering to the daily perishable waste being generated in the KMPS.

Figure 3 Composting facility within the premises

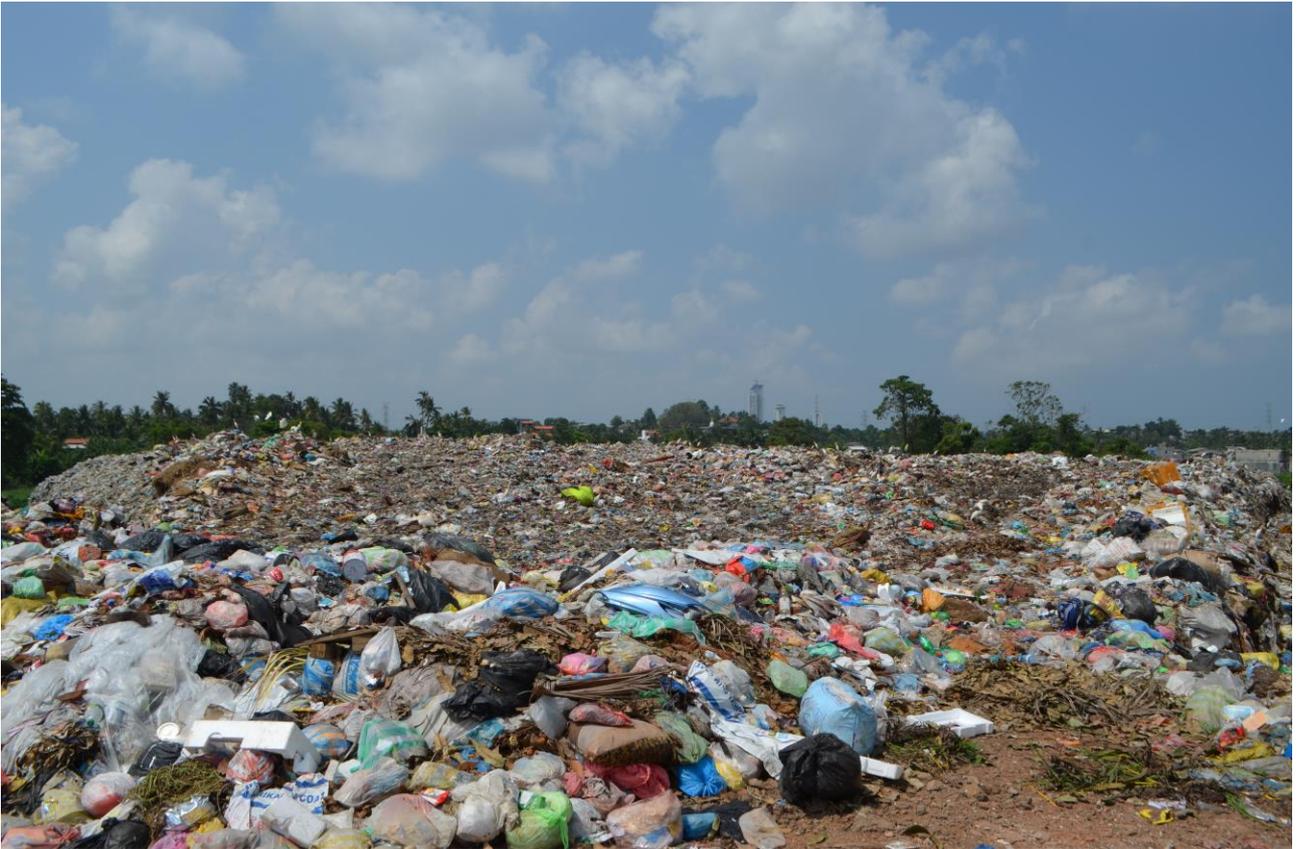
3. The nature of the waste was observed to be heaps of cloth pieces, polythene, tyres, plastic bottles, Styrofoam containers, a heavy thick rope used in ships, a heap of cardboard boxes, electronic waste including CDs, DVDs, cassettes, etc. and glass. It looked more like an industrial waste dump rather than a municipal waste yard.

Figure 4 Types of waste dumped

7. Dumping of all industrial waste in such dump yards should be stopped and commercial industries need to manage their own waste in an environmentally and socially acceptable way through segregation, recycling and incineration. It should be the responsibility of each industry. All BOI projects and export processing zones should have common regional facilities for the management/ disposal of such waste and it shouldn't be the burden of the government at the expense of the health and well being of another group of innocent people living in a completely different area.

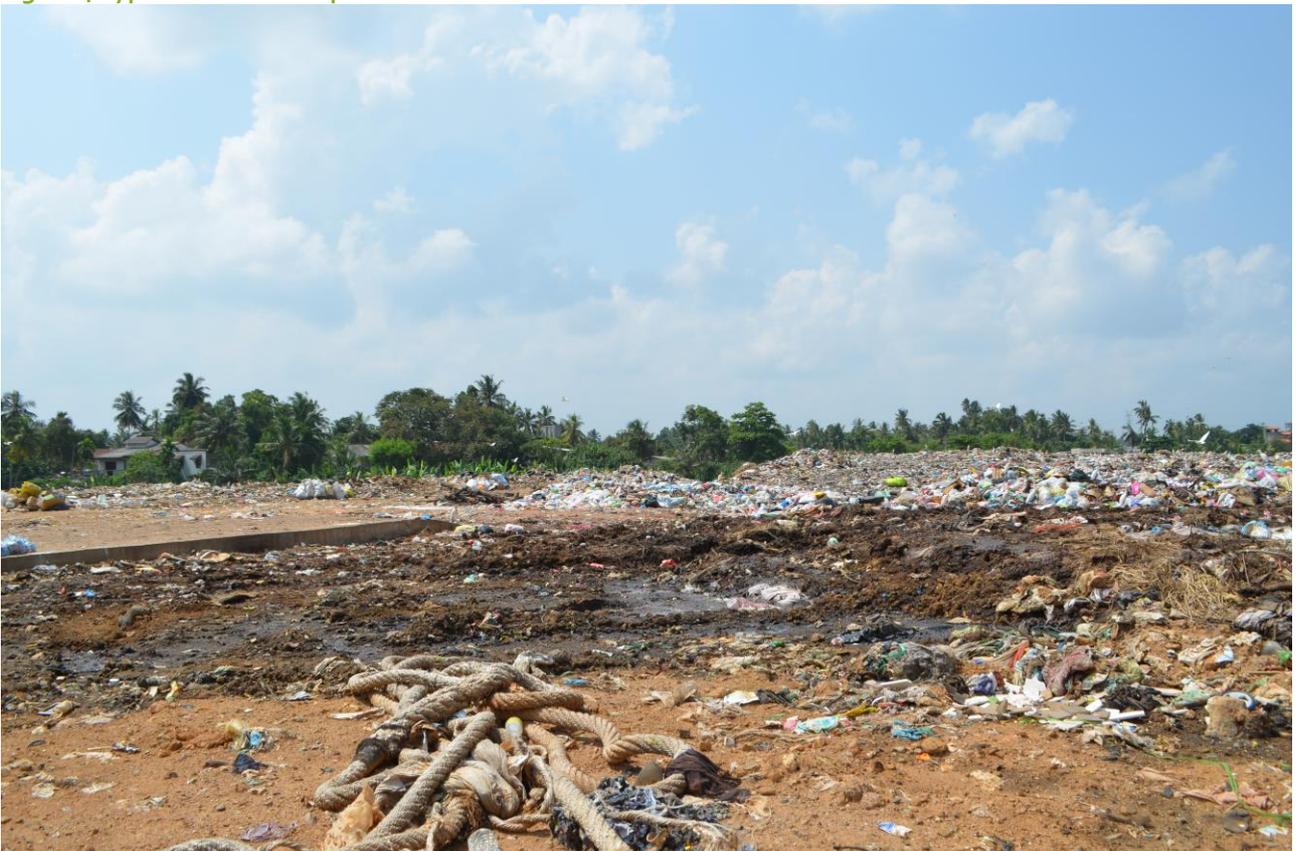
Figure 5 Types of waste

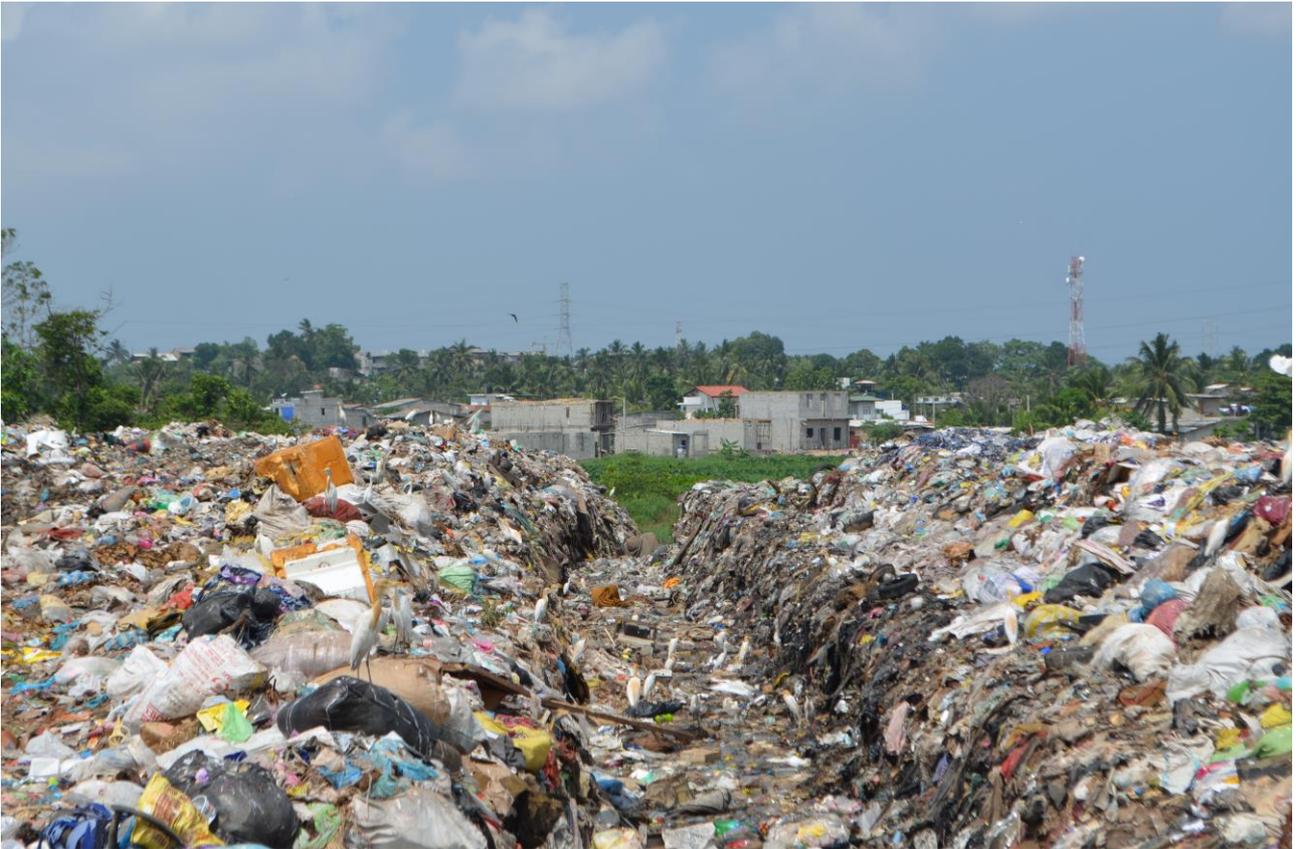
4. The dump was filled with birds like cranes, crows and house flies.
5. A few water logged areas were visible bordering the dump as well as within the dump indicating that the several drainage ways were blocked by the waste dump. Residents

6. A canal that drains waste water of the Kotikawatte town, passes through this wetland. However, this canal finds a dead end once it reaches the dump. People mentioned that the canal was freely flowing across this land and later on garbage was dumped on top of it.
7. Albeit compost production with the perishable or the decomposable waste, the odour was extremely strong indicating the availability of unprocessed decomposable waste. Odour emanated from both the dump and the composting yard.

Figure 6 Blocked drains within the garbage dump

9. In the current site, since the condition is not acceptable both socially and environmentally, it is recommended to get an expert opinion to take measures to mitigate all current nuisances to people and avoid further degradation of the surrounding environment including waterways, ground water and wetland ecosystem. The action plan for restoring the site should be implemented under the close supervision and consultation of Central Environmental Authority and a few members of the community. Community participation is crucial in this exercise.

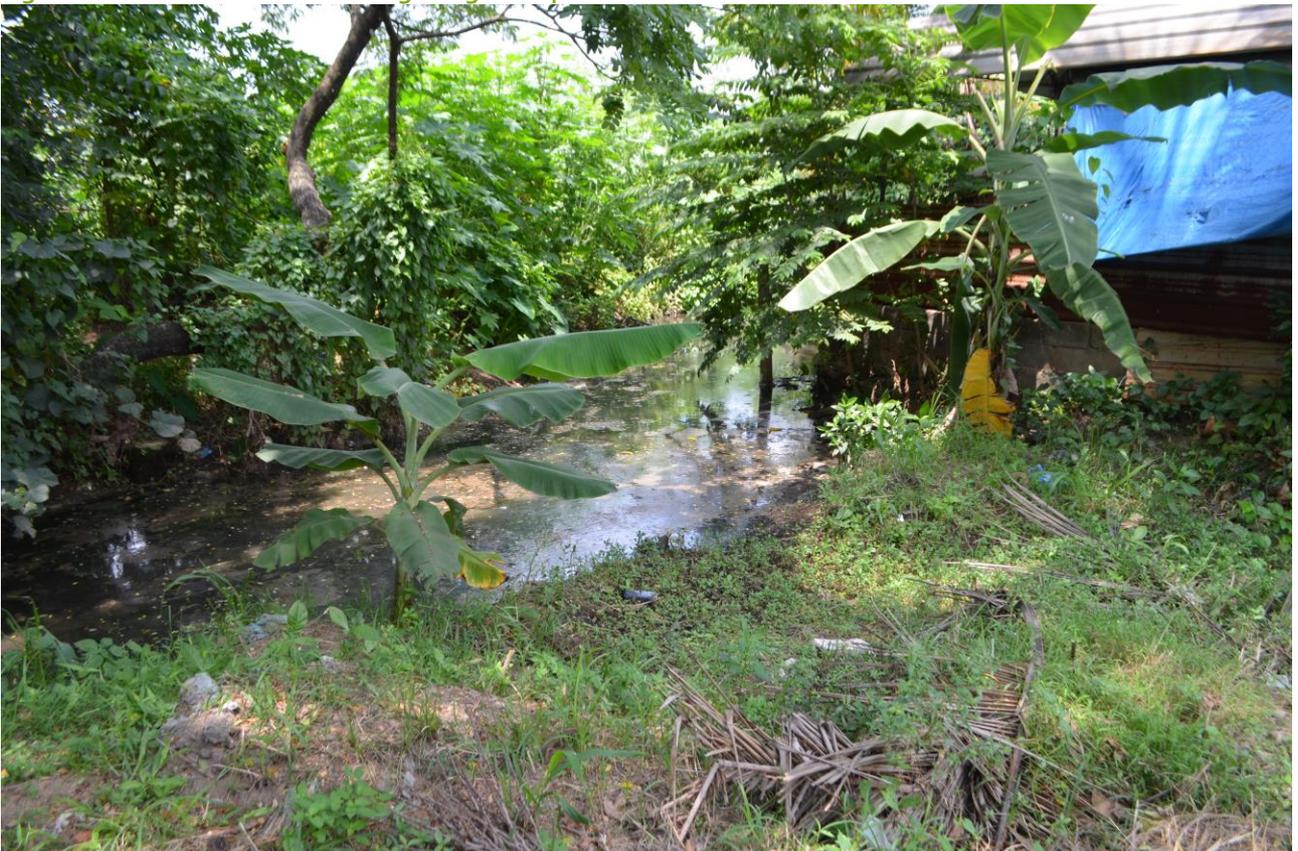
Figure 7 Stagnant water next to residential areas

In addition, as their land are bordering a previous wetland, the slightest rainfall is now causing floods as a result of clogged waterways. It was further explained that the flood water is always black and grimy obviously owing to contamination through garbage. This area had been severely affected by the May 2016 floods, with flood water levels rising up to 10-12 feet. This had remained for 8-10 days due to the absence of a proper drainage system. They further mentioned that the drainage canal which used to drain such water in the past has been completely blocked by the garbage dump. In addition to the water, waste from the garbage dump had flowed in to their houses.

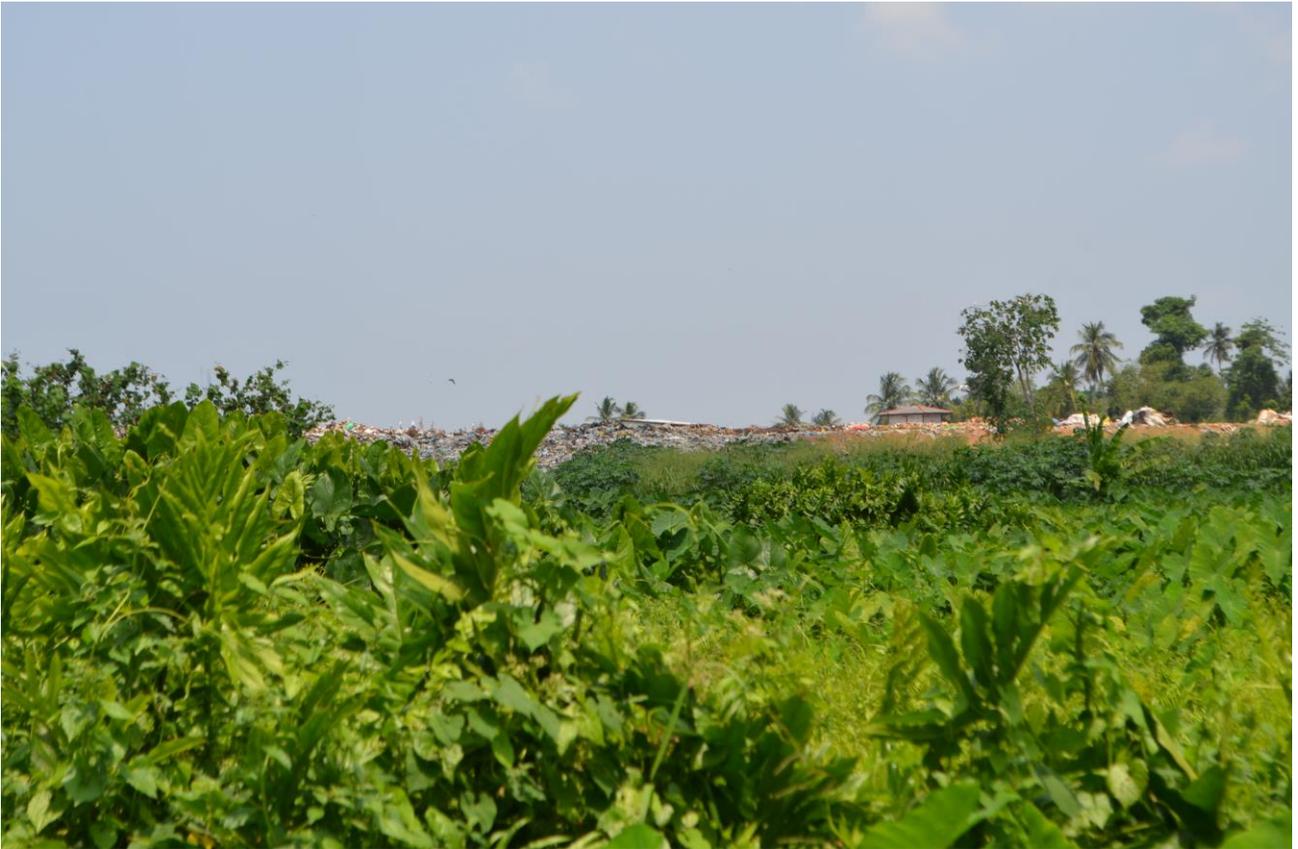
informed that this land was the lower most in elevation within the area, which served as a paddy field in the past as well as the drainage area after rainfall. It was a part of a wetland that fulfils the service of absorbing water.

Figure 8 The remnants of the previous wetland

As it appears in the satellite images taken in the year 2004 this entire area had been a wetland. In general a wetland is a valuable ecosystem due to key ecosystem services it provides. Further, wetlands are considered to be amongst the most productive ecosystems in the world, in comparison to rain forests and coral reefs (Gopal 1999; Zhao and Song 2004). In general this area had mostly been a wetland that has got filled eventually over the years due to urbanisation. The considerably large and the closest wetland to this present site is the Kolonnawa wetland. Therefore, a scientific prediction can be made that the affected site has had similar fauna and flora to Kolonnawa wetland prior to this destructive decision to dump garbage was made. According to a

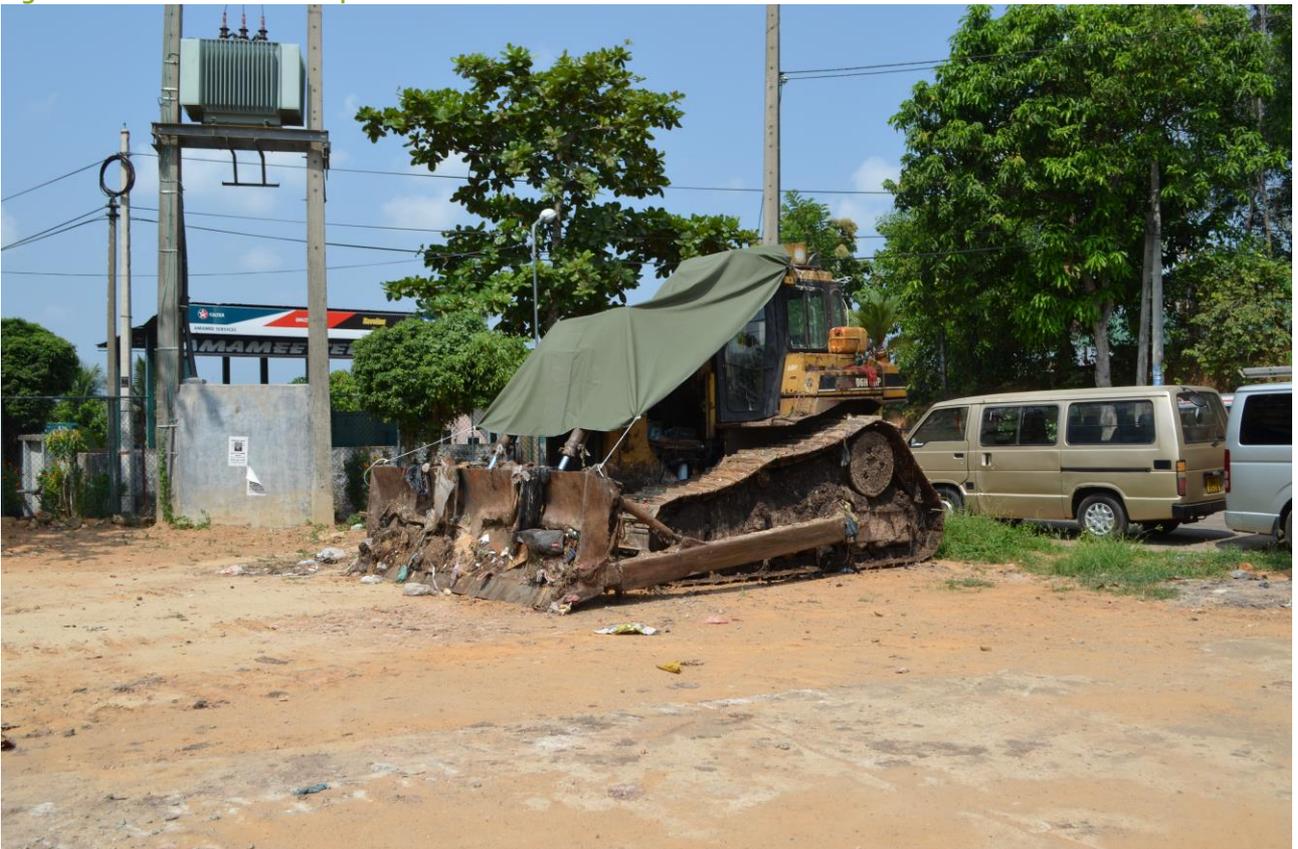
Figure 9 Cemetery premises

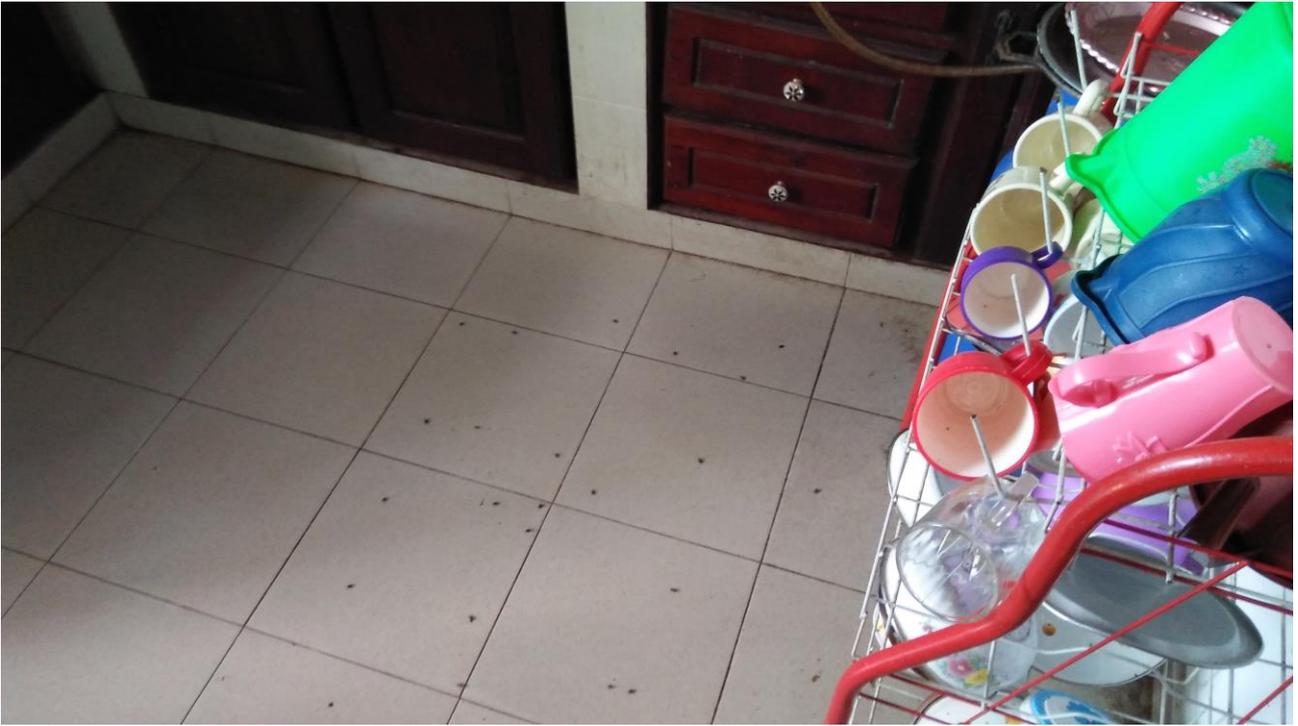
Figure 10 Flies observed during the visit

5. Dumping of waste in the alternative site should be carried out under controlled conditions, in such a way that residents will not be affected and the environment will not be degraded. Measures should be taken to avoid scavenging and transporting of waste through birds and odour should be minimised.

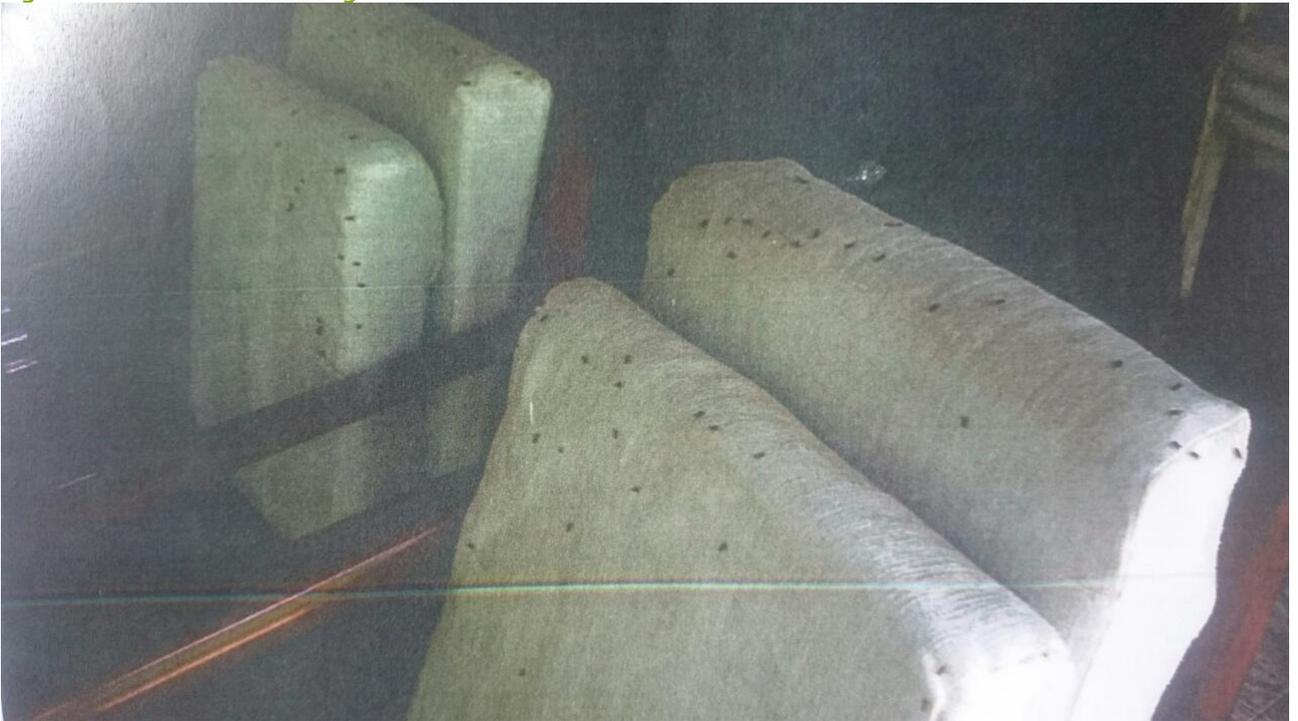
Figure 11 Flies in a living room (Source: Hasitha Ranasinghe)

The foul smell which is the most apparent source of discomfort felt around the entire area was said to escalate during windy nights and subsequent to rainfall. The residents complained how they are unable to enjoy a meal or host guests within their premises. They have gradually experienced a massive increase in house flies and mosquitos over time resulting in an unusual escalation in diseases such as: Dengue, diarrhea and skin rashes apart from constant fever and coughing in children. Out of the 15 household representatives encountered, in more than 5 families, there had been Dengue patients. It was mentioned that food cannot be left exposed for even a few seconds due to the large number of flies all over the area.

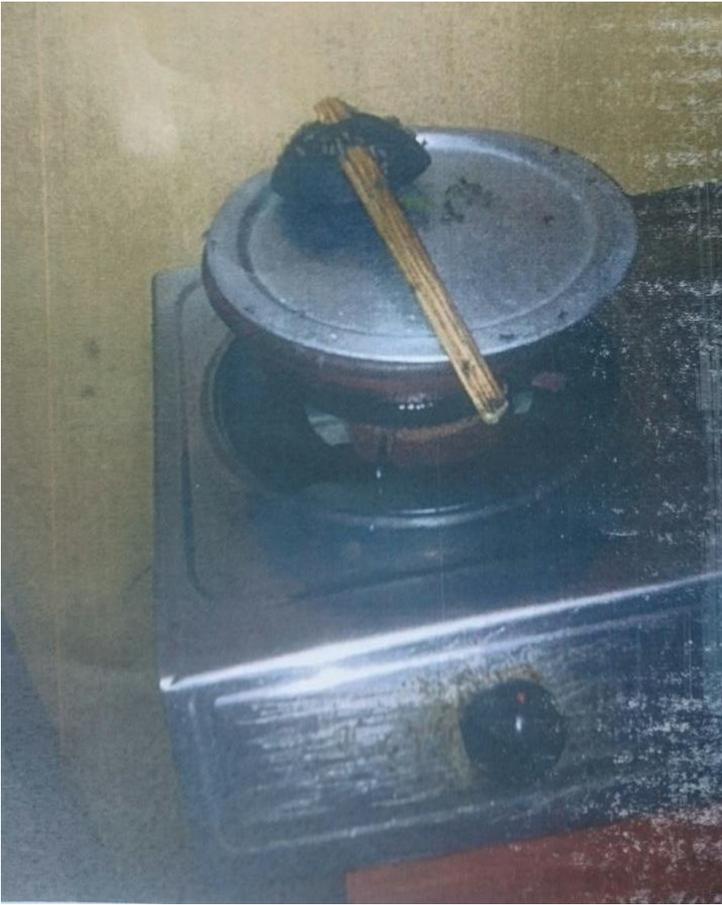
Figure 12 Flies in the kitchen (Source: Hasitha Ranasinghe)

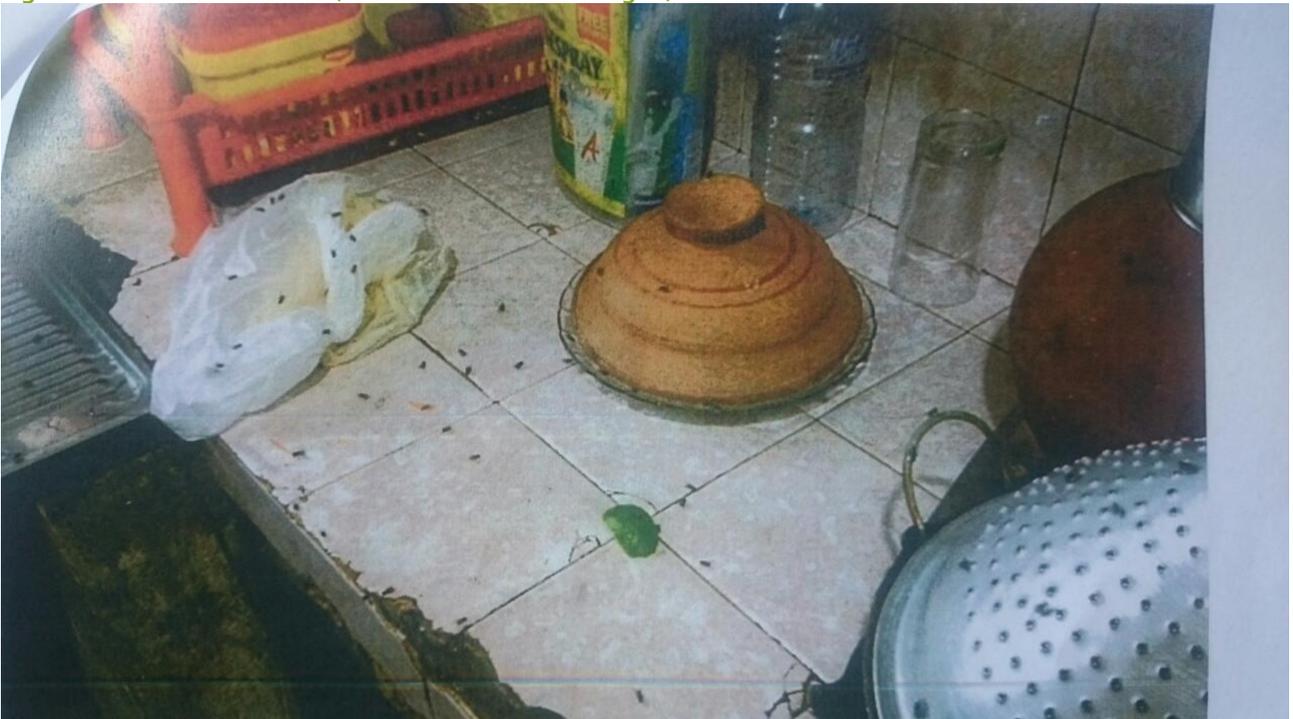
Figure 13 Flies in the kitchen (Source: Hasitha Ranasinghe)

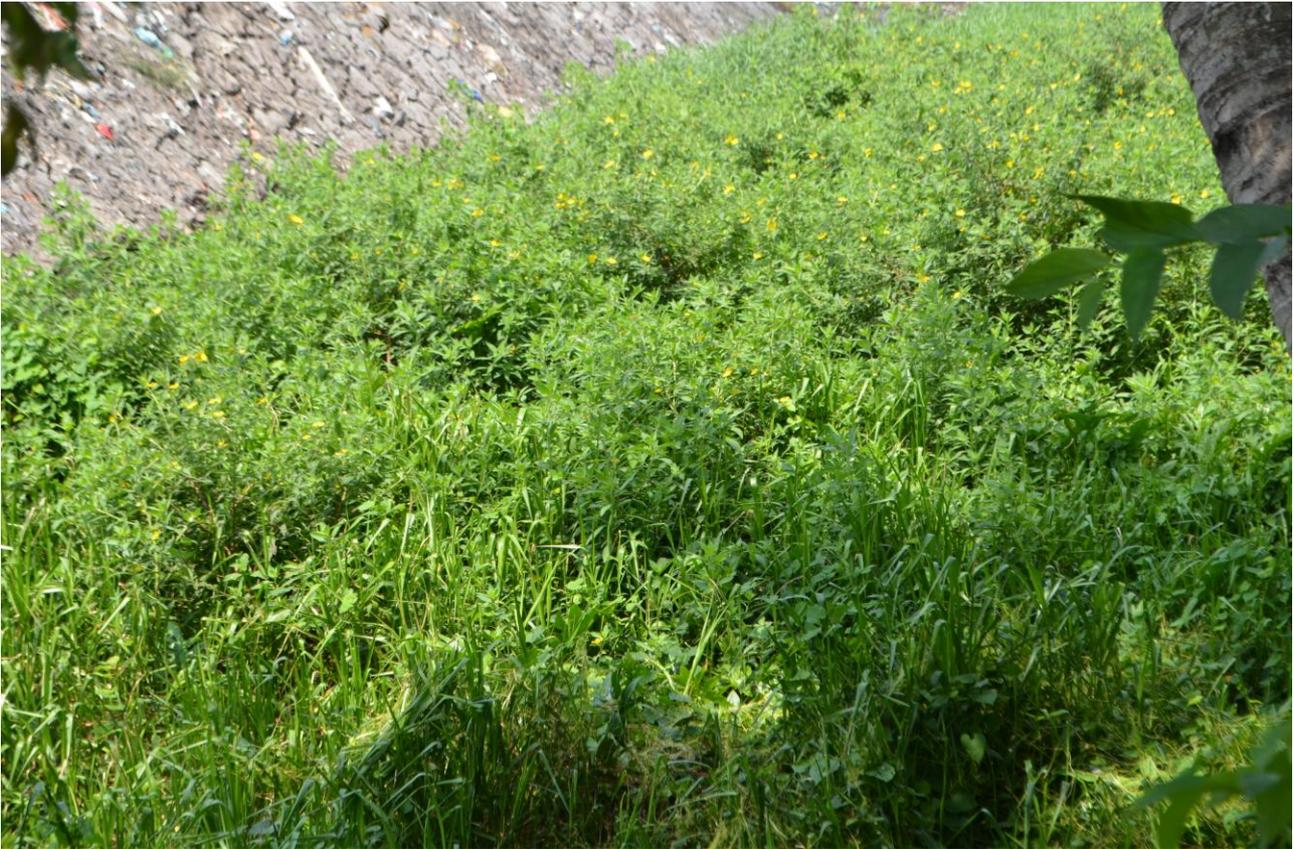
Such an ill managed dumping site would not limit its impacts by displacing native species but also will introduce alien invasive species that would make it worse for the surviving flora and fauna community in the surrounding to persist. Such invasive species observed at the present site include: *Panicum maximum* (Rata thana), *Cuscuta campestris* (Aga-mula-nathi wel) and *Salvinia molesta*. *Millingtonia hortensis* *Muntingia calabura* and *Ludwigia peruviana* are the potentially invasive species (Ministry of Mahaweli Development and Environment 2015) recorded during the visit.

Figure 14 *Panicum maximum* (near) and *Ludwigia peruviana* (far)

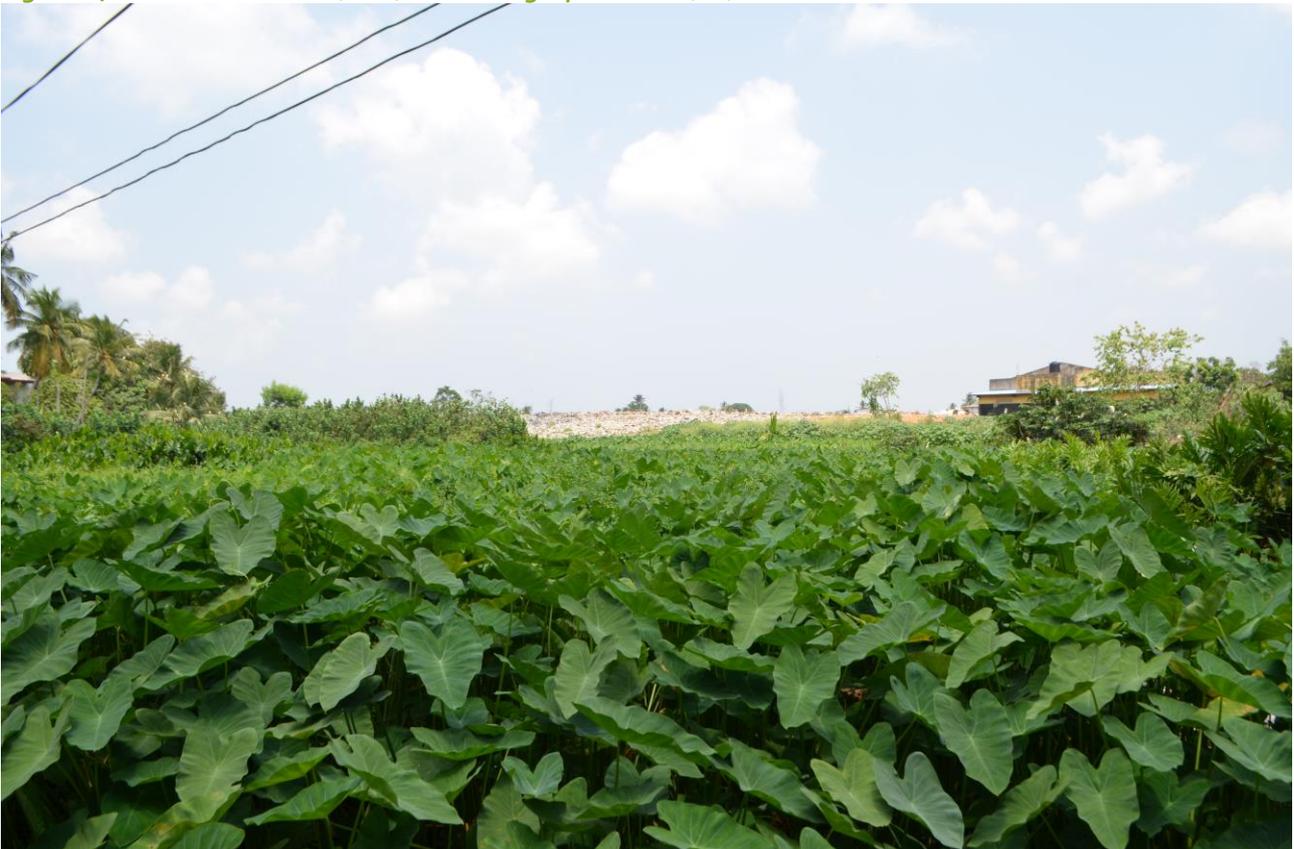
Figure 15 Gahala plants
